# BEDFORDSHIRE ARCHAEOLOGICAL JOURNAL

VOLUME III 1966

Volume III 1966

EDITED BY  
JAMES DYER

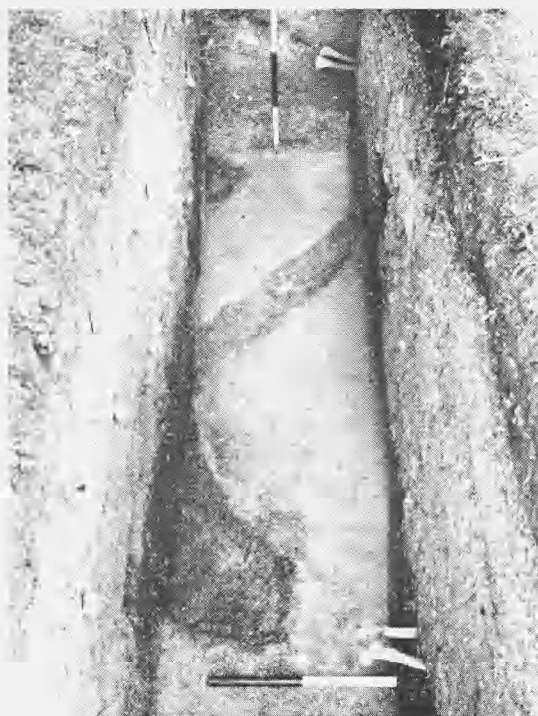
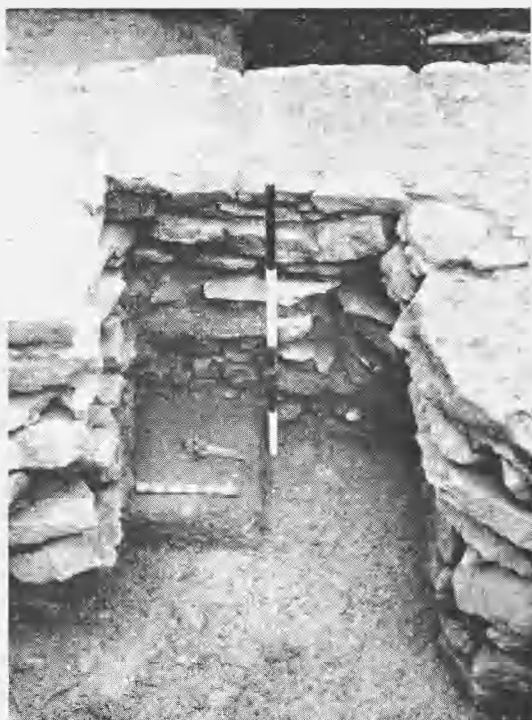
Plate 3a. Roman features below medieval burials.

3b. Burial cut by Abbey 2 robber trench and Abbey 3 cloister wall.

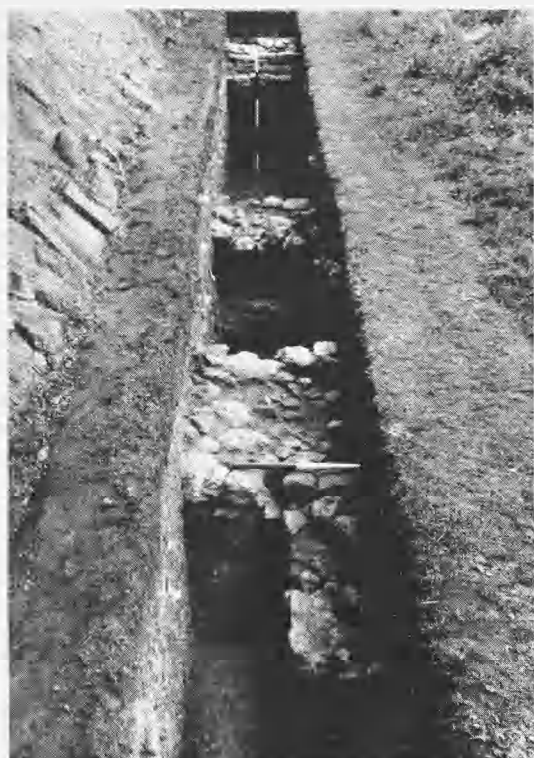
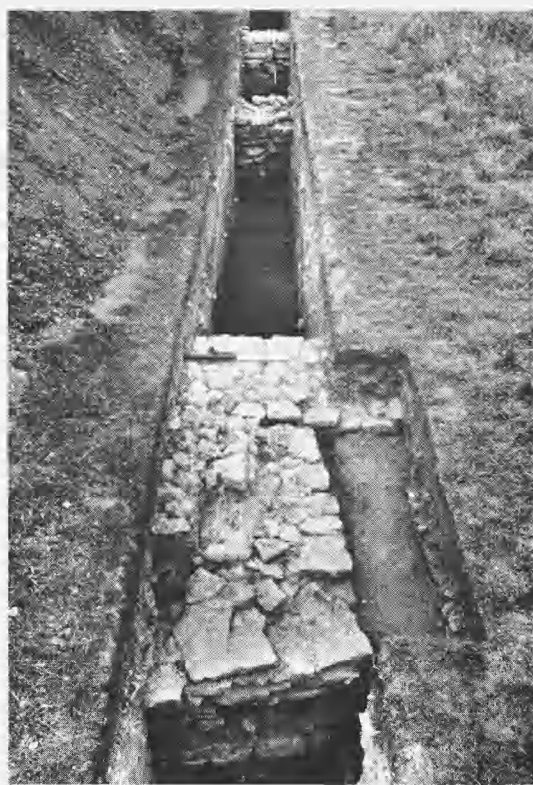
Plate 4a. View facing east across eastern side of Abbey 3 claustral buildings.

4b. View facing north across south side of Abbey 3 claustral buildings.

Excavation began with trial trenching (fig 2) (pl 4a, 4b). The position of the ruined mansion

*The east range* (pl 4a). The trial trench across the eastern side of the garth cut across a wall 11 ft. 0 in. east of the eastern walk wall. Level with its western offset was a discontinuous occupation layer. This width seems rather narrow for a range of buildings. Two possible explanations present themselves. The wall under discussion was found at the limit of the area available for trial trenching; a further wall could exist, making this a central, and possibly a sleeper wall for columns in the ground floor of the presumed dormer range. Alternatively, this wall, with its size and strength, could still be the eastern wall of the eastern range, whose dormer, customarily on the first floor, extended over the cloister walk also, as at Wilberfoss.<sup>13</sup> This latter explanation could account for the size of the buttress on the garth eastern wall, but not for the shallowness of its construction, with its lowest course only 3 ft. 0 in. from the modern ground surface.

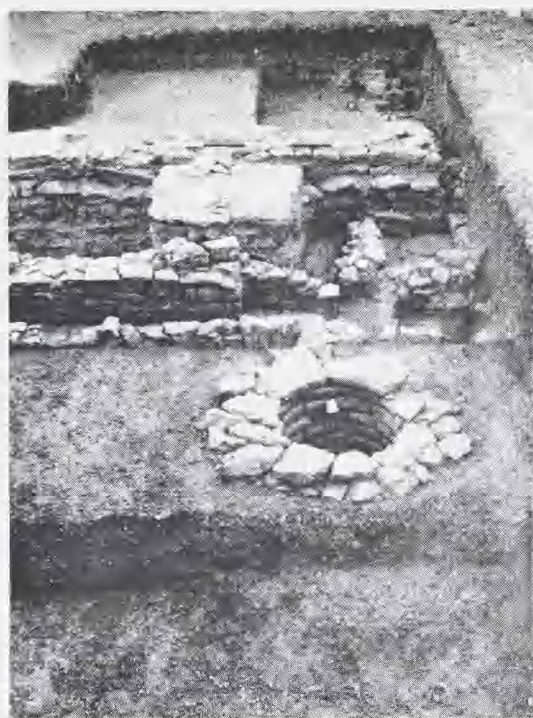
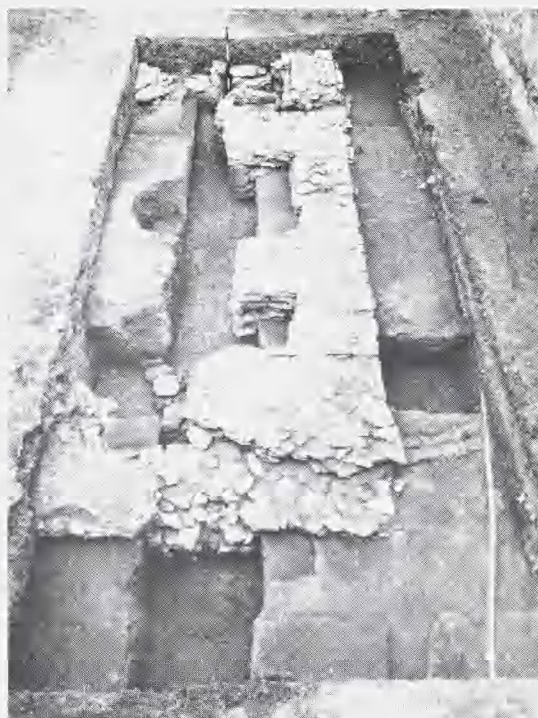
Plate 6a. Abbey 3 'lavatorium' showing wall, drain and tank, set against cloister wall. Facing south.  
 6b. South-western corner of Abbey 3 garth and robber trenches for Abbey 2.
